RPSC-Winter Course L-9 (2)

Earthquake at Kashiwazaki-Kariha
NPP

1. Outline of the Earthquake
2. Kashiwazaki-Kariha NPP
3. Maximum Acceleration of the Earthquake
4. Response Curve of the Earthquake
5. Plant Status at the Earthquake
6. Impacts of the Earthquake
7. Detailed Evaluation Result for Faults
8. Evaluation for Seismic Wave Propagation
9. Re-Evaluation Result & Current Plant Status
10. Experience through the Earthquake

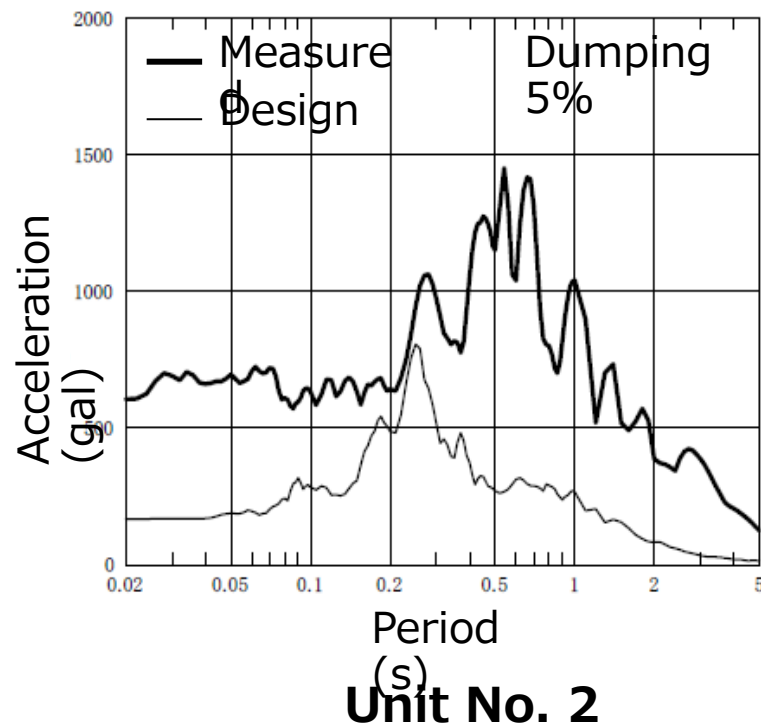
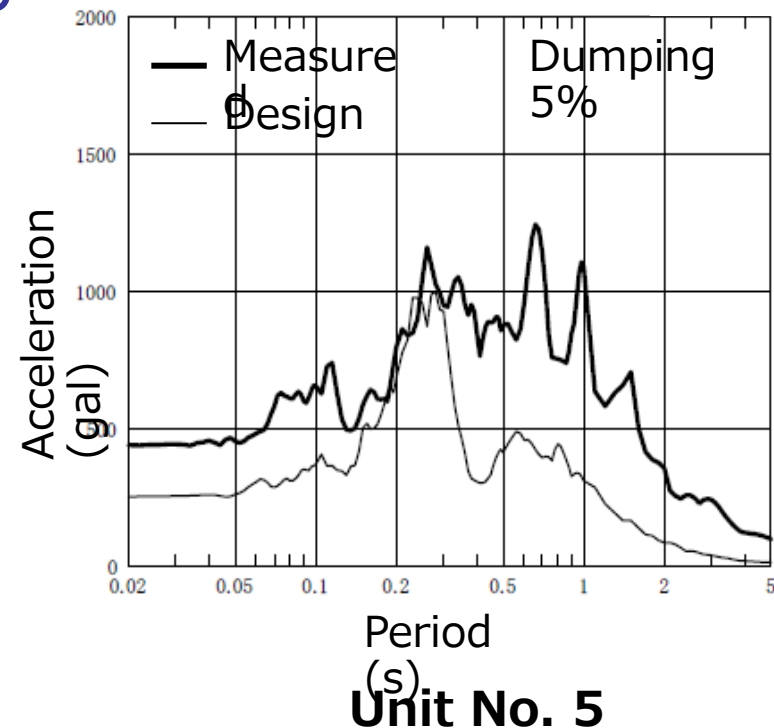
4. Response Curve of the Earthquake

- Response Curve on Reactor Building Base Mat (Horizontal)
- Exceeding the Design Curve in All Period
