# **The 2011 Off Pacific Coast of Tohoku Earthquake/Tsunami and Damage to the NPPs**

Yuichi UCHIYAMA

June 2011      JNES Seismic Safety Div.

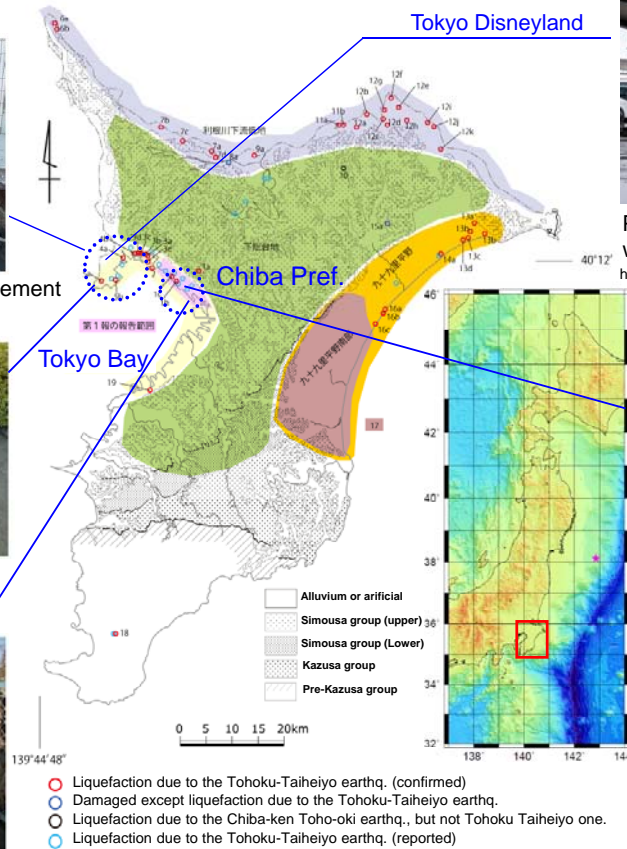
Around Chiba port: Subsidence of a electric pole and large volume of sand boil

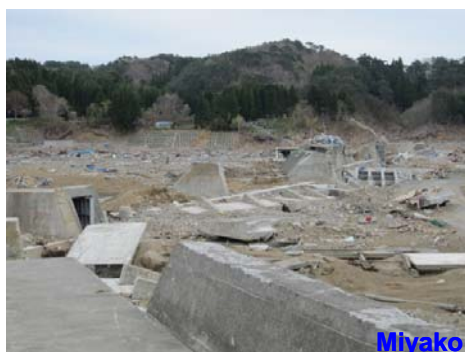
- Taro district, Miyako case : **10m-high** sea wall with a local nickname of “the Great Wall of China”, was destroyed by the 15m-high tsunami.
- Otabe district, Fudai Village case : **15.5m-high** sea wall was constructed **according to the village chief's strong willing**, and it blocked the 15 m high tsunami and successfully protected the houses in this district. As a lesson learnt from great damages caused by the Meiji Sanriku tsunami and the Showa Sanriku tsunami, local wisdom of preparedness against a 15m high tsunami has been widely disseminated in this area.
- These two examples give some suggestion when we examine to prepare for violent natural phenomena.

The 10m-high tide embankment was destroyed in Tao district, Miyako city, Iwate prefect.

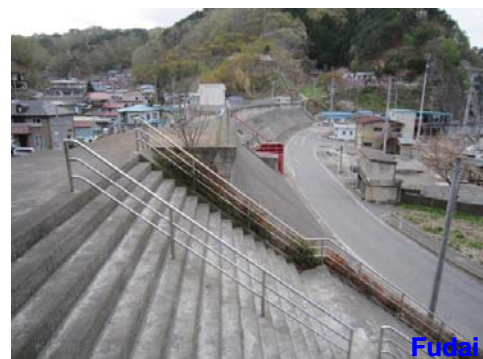
The 15.5m-high tide embankment is sound in Otabe district, Fudai village, Iwate prefect.

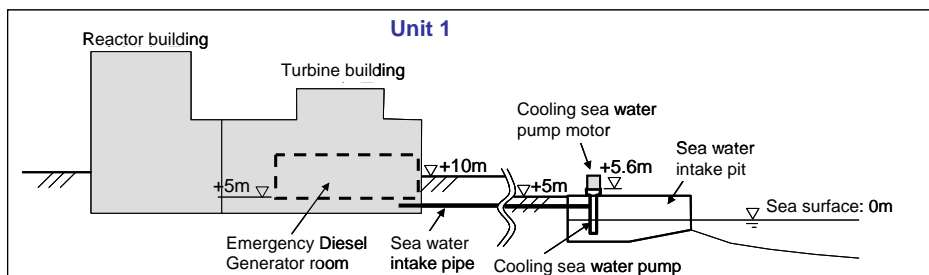
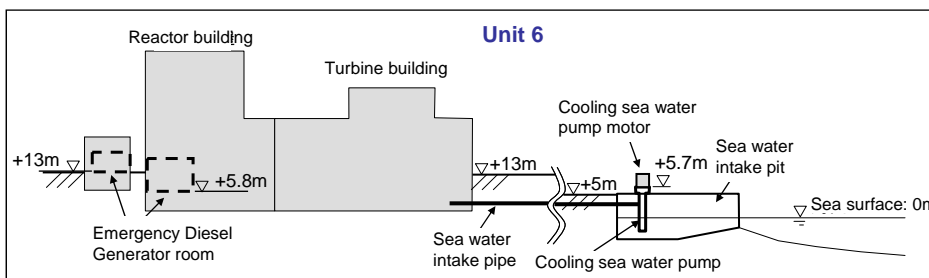
Inundation

**Sea water system facilities of all units were inundated by tsunami.  
Only one EDG of air cooling was survived in the site after tsunami.**

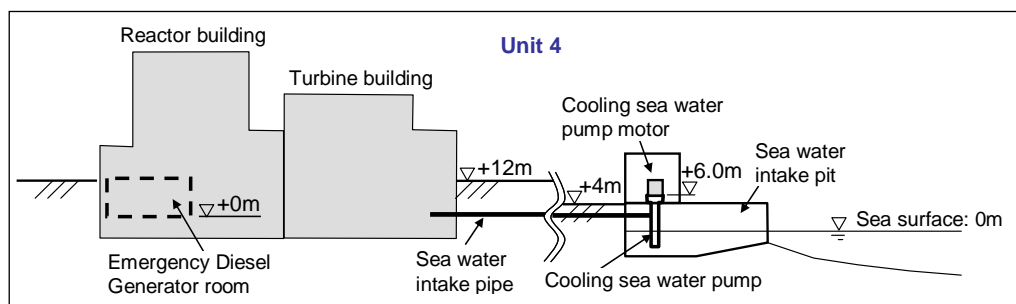
Emergency DGs at underground floor of Reactor Building stopped after tsunami.

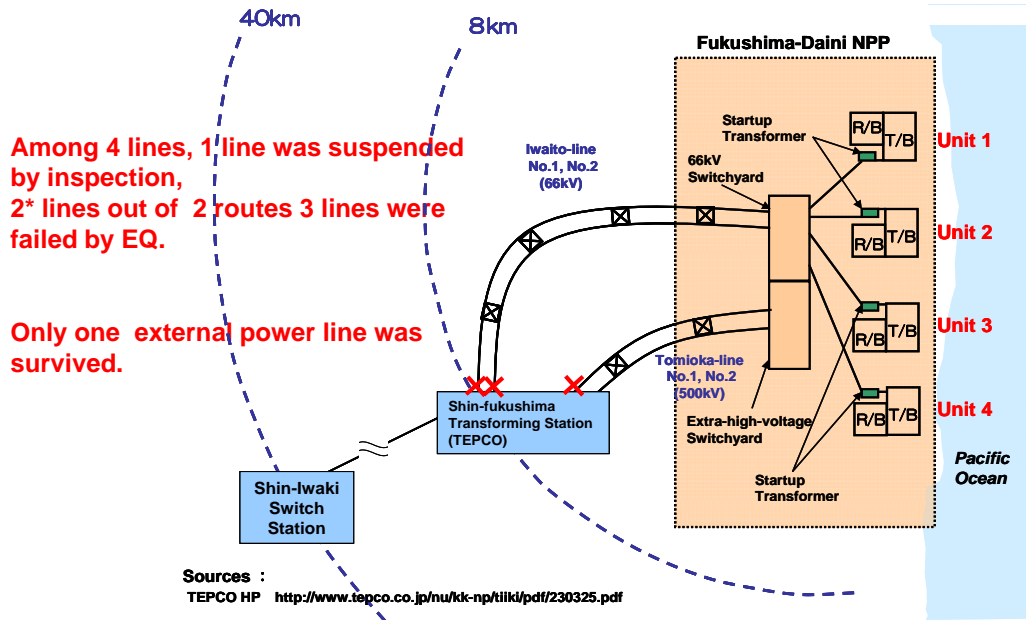
- External power was supplied through 2 routes 4 lines for Unit 1 to 4;  
 Tomioka route : line 1 and 2 (66kv) 1 line served and 1 line failed  
 Iwado route : line 1 and 2 (500kv) 1 line was inspection outage, 1 line failed  
 \* Observed JMA intensity around the Shin Fukushima transformer station:  
 Intensity 6 strong
- Unit 3 was brought to cold shut down thanks to survived EDGs and sea water pump next day.
- Sea water cooling pumps for #1, 2, 4 were failed, but thanks to survived external power and recovery works, these plants were brought to cold shut down in 4-5 days.

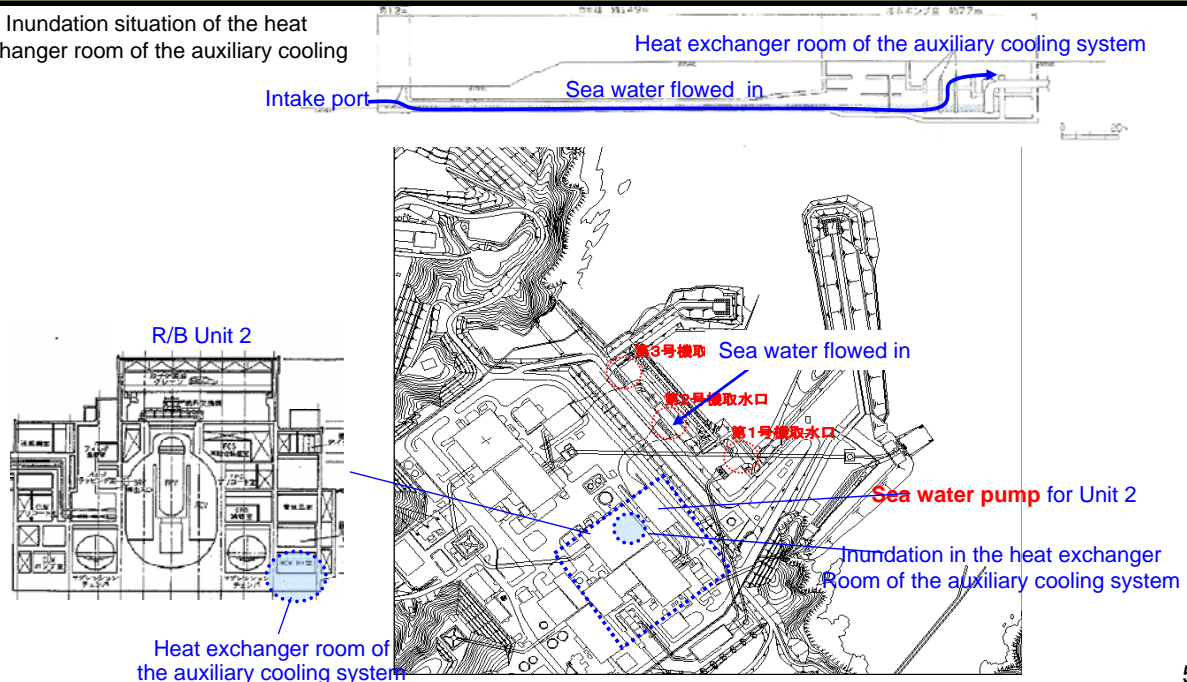
- Construction Arrangement of the auxiliary cooling system : Water intake port, Sea water pump, Sea water pump room, Heat exchanger room.
- Height of the sea water pump room: O.P. 30m.
- Tsunami damage situation: tsunami flowed into the sea water pump room through the water intake port of Unit 2; through the underground trench, it further inundated a basement room of RB, and the auxiliary heat exchanger room (subbasement of RB).

Inundation situation of the heat exchanger room of the auxiliary cooling

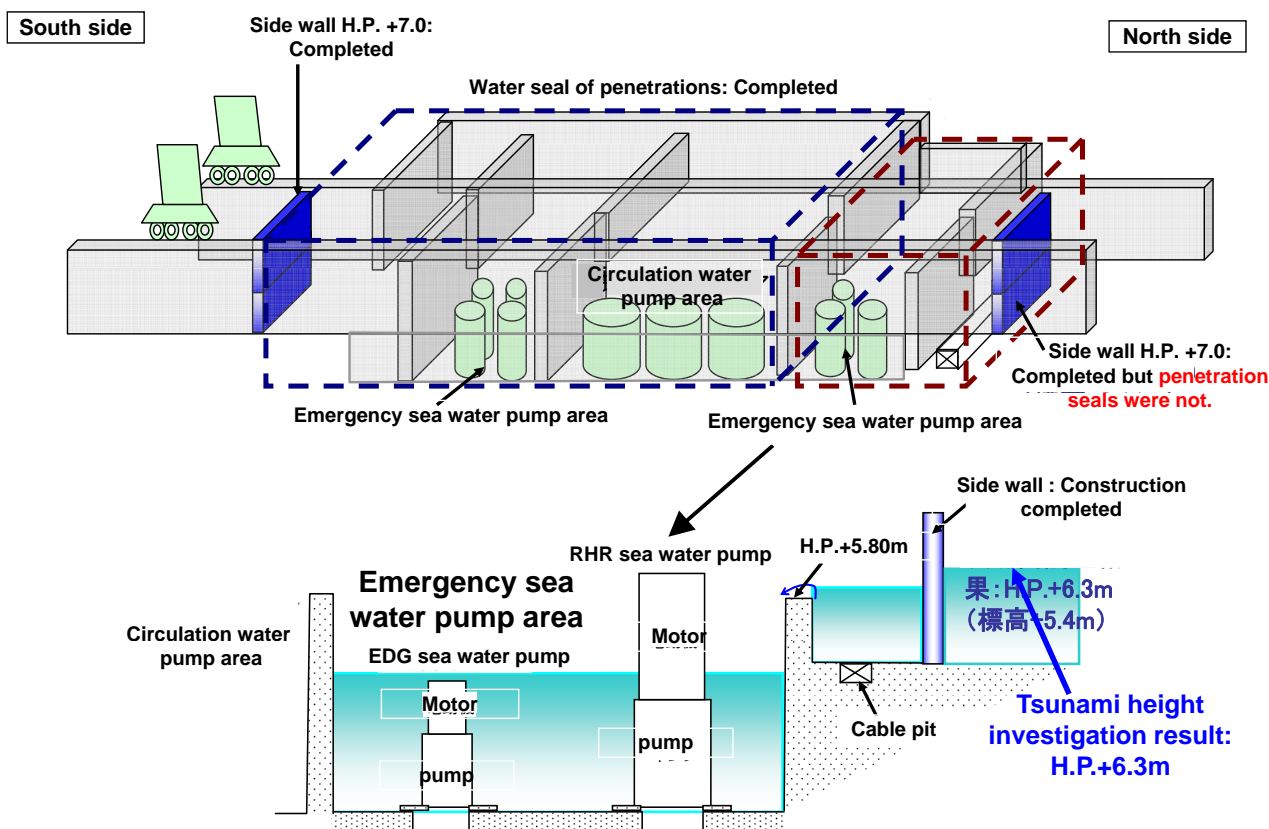
- Run-up height: About **H.P.+6.3m**
- Tsunami did not exceed side wall H.P.+7.00m
- Inundation to north side pump room seemed to be caused by water infiltration through penetration holes. (South side pump room was secured.)
- Tsunami did not reach to main grade level (**H.P.+8.89m**) where main buildings were located
