RPSC-Winter Course L-9 (2)

Earthquake at Kashiwazaki-Kariha
NPP

1. Outline of the Earthquake
2. Kashiwazaki-Kariha NPP
3. Maximum Acceleration of the Earthquake
4. Response Curve of the Earthquake
5. Plant Status at the Earthquake
6. Impacts of the Earthquake
7. Detailed Evaluation Result for Faults
8. Evaluation for Seismic Wave Propagation
9. Re-Evaluation Result & Current Plant Status
10. Experience through the Earthquake

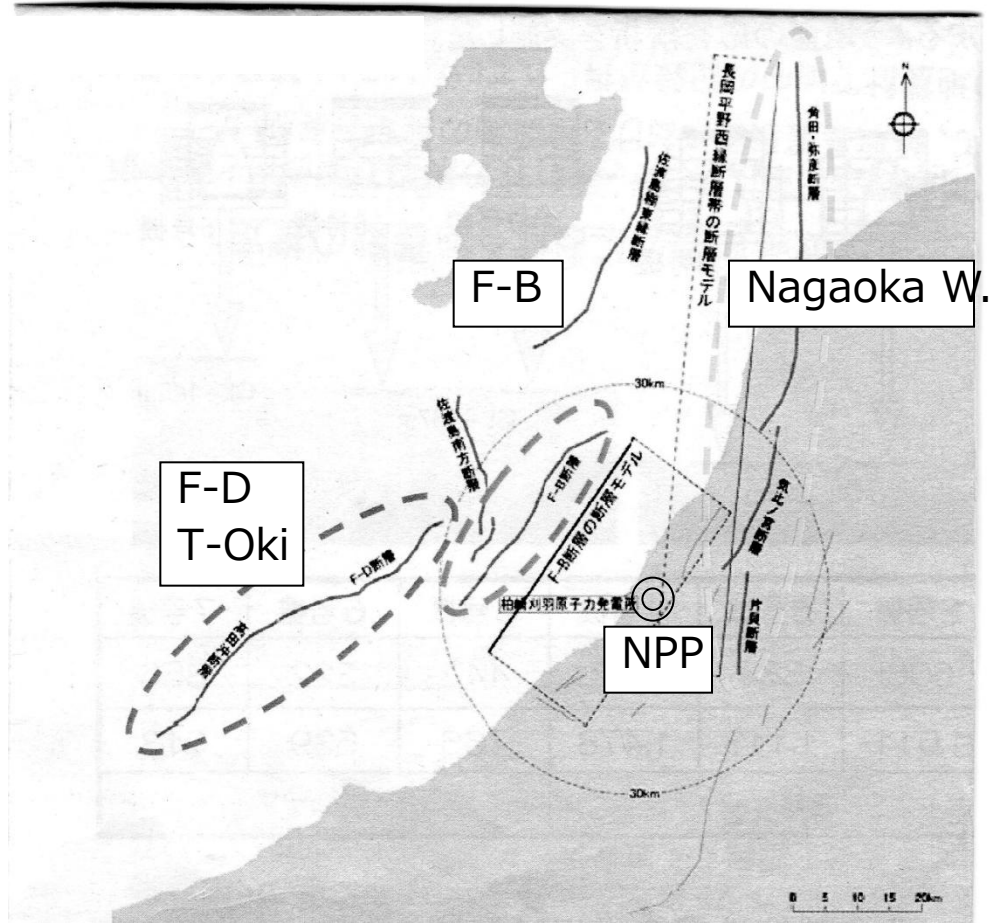
7. Detailed Evaluation Result for Faults

Important Faults

Name	Length	Mag.
F-B	34 km	M7.0
Nagaoka West	91 km	M8.1
F-D Takada-Oki	55 km	M7.7
