# **The 2011 Off Pacific Coast of Tohoku Earthquake/Tsunami and Damage to the NPPs**

Yuichi UCHIYAMA

June 2011      JNES Seismic Safety Div.

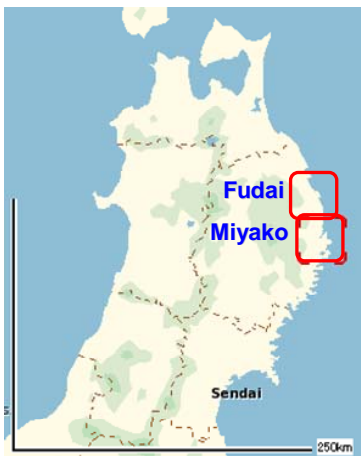
- Taro district, Miyako case : **10m-high** sea wall with a local nickname of “the Great Wall of China”, was destroyed by the 15m-high tsunami.
- Otabe district, Fudai Village case : **15.5m-high** sea wall was constructed **according to the village chief's strong willing**, and it blocked the 15 m high tsunami and successfully protected the houses in this district. As a lesson learnt from great damages caused by the Meiji Sanriku tsunami and the Showa Sanriku tsunami, local wisdom of preparedness against a 15m high tsunami has been widely disseminated in this area.
- These two examples give some suggestion when we examine to prepare for violent natural phenomena.

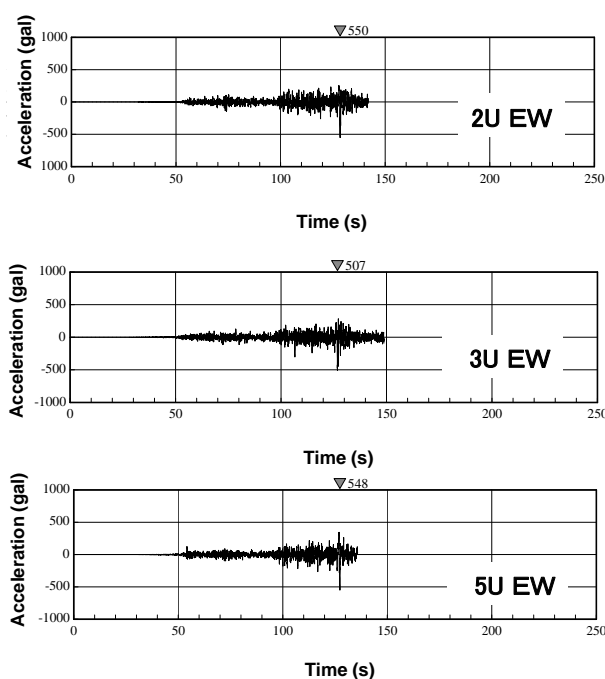
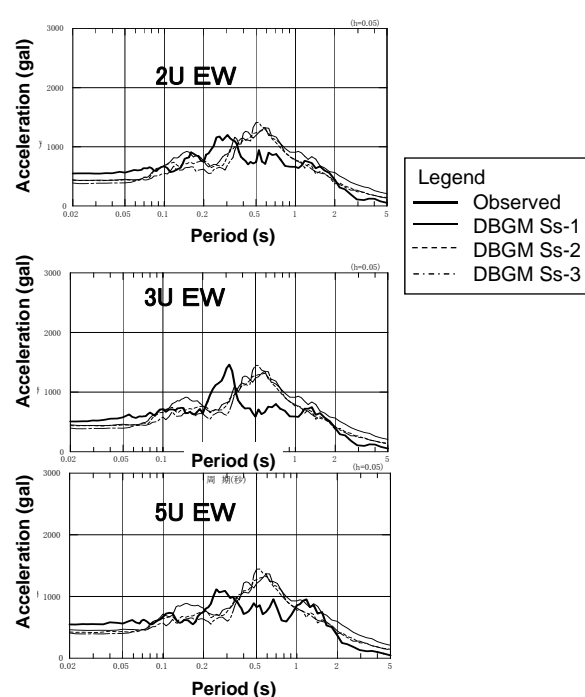
- Observed ORS lower than Ss spectra (DBS) in the almost period
- Observed ORS overshoot max. 30 % Ss spectra (DBS) in the period between 0.2 to 0.3 second
- Tokyo Electric Co. :  
No safety related facilities in this band of period

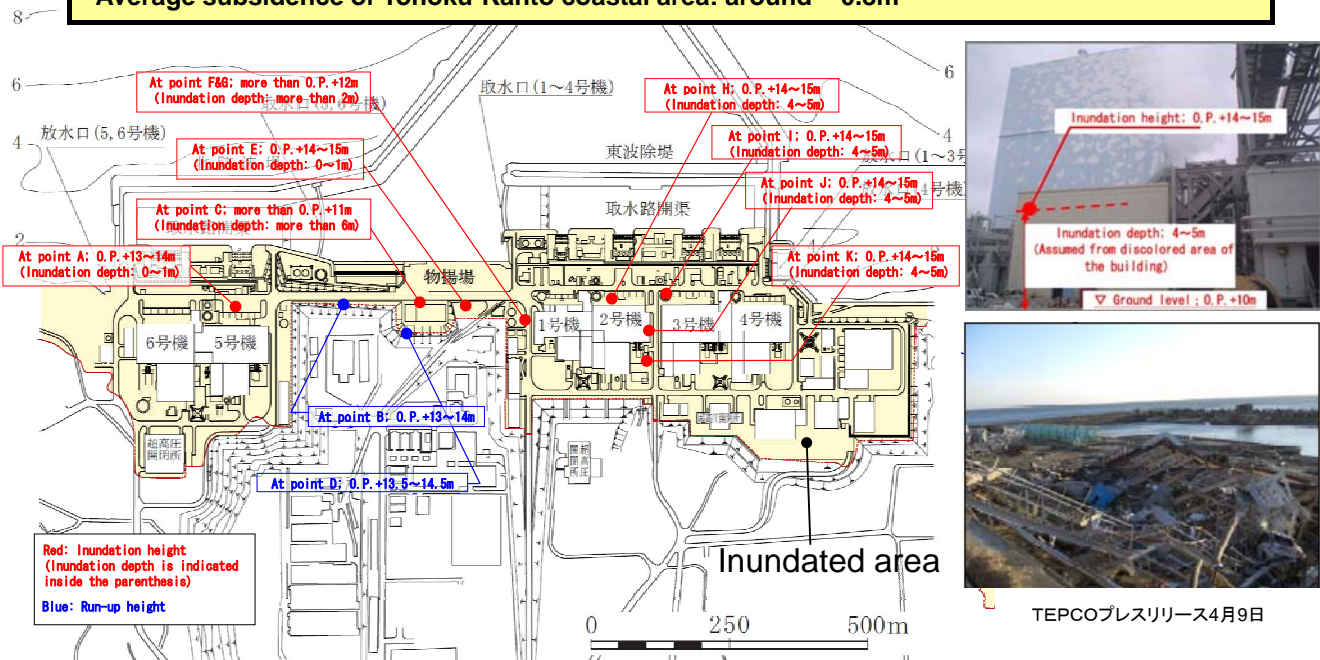
### ① inundated area and height

Unit	Height (m)	Site elevation (m)
Around #1 - #4	14~15	Around 10
Around #5,#6	13~14	Around 12~13
Average subsidence of Tohoku-Kanto coastal area: around - 0.8m

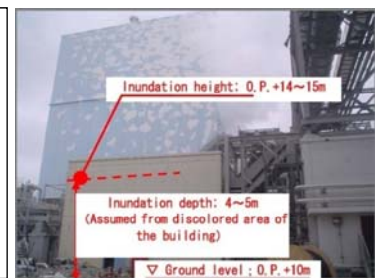
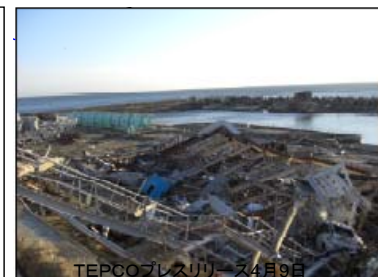
Inundation

**Sea water system facilities of all units were inundated by tsunami.  
Only one EDG of air cooling was survived in the site after tsunami.**

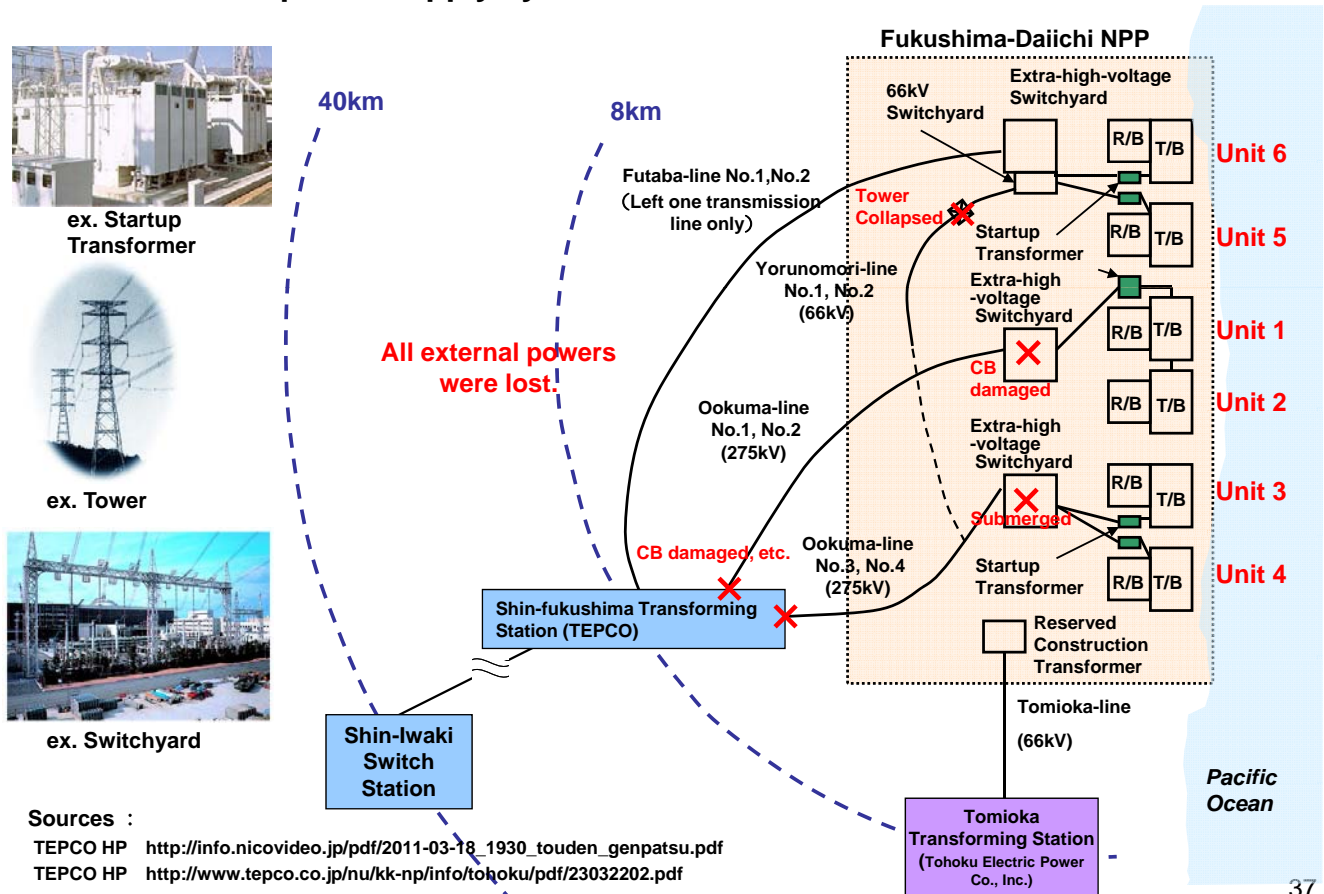
## ② External power supply system

- **Units 1 and 2 :** Contactor of extra high voltage switching station damaged by earthquake
- **Units 3 and 4 :** Control panel of extra high voltage switching station inundated by tsunami
- **Units 5 and 6 :** Steel tower #27 to start up switchyard collapsed
- **Outside the site:**
  - Around the Shin-Fukushima transformer substation: Intensity 6 strong of JMA intensity
  - Facility of the station as switchgear etc. damaged by earthquake.
  - 2 system 4 feed line of 275kv for unit 1-4 and 1system 2 feed line for unit 5-6 failed.

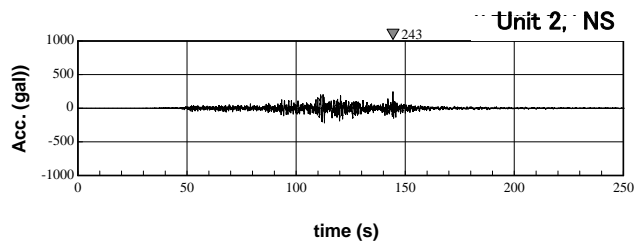
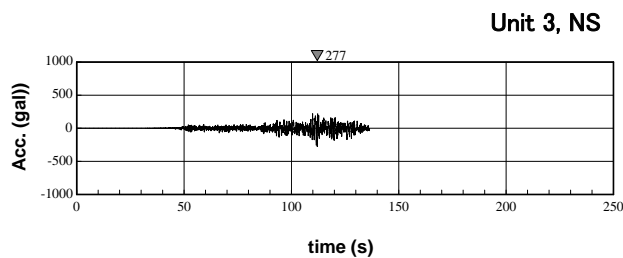
Acceleration seismogram at foundation mat

- Characteristics of response spectrum (ORS) of observed motions
- Observed ORS lower than Ss spectra (DBS) in all period

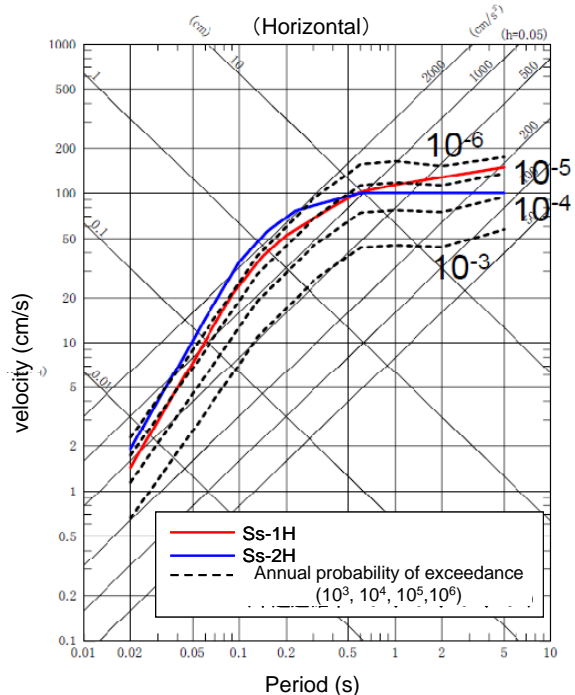
Annual exceedance probability of DBGM Ss of Fukushima No2 site

Annual exceedance probability (AEP) of Fukushima Daini (Fig2-9)

AEP of Ss:  $10^{-4} \sim 10^{-5}$

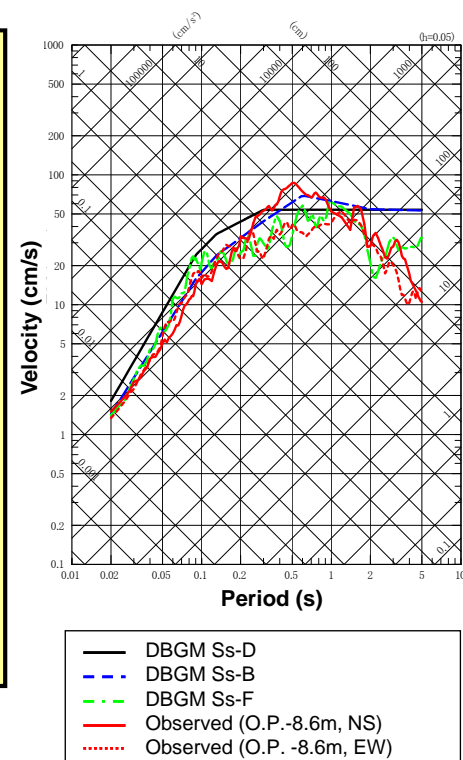
### ■ Characteristics of observed response spectrum (ORS) of recorded motions at the vertical array (O.P. -8.6m) :

- ORS overshoot Ss spectra (DBS) in the period between 0.2 to 1.0 second
- Tohoku Electric Co. : No safety related facility in this period

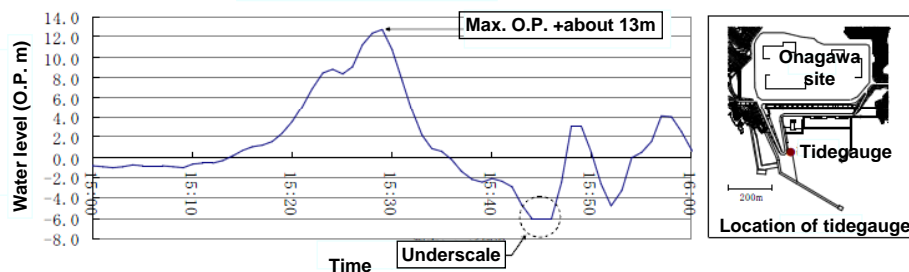
Time history recorded at the site (March 11, 2011)

- Height : around O.P. 13m
- Site grade level : 14.8m (before EQ, subsidence about 1m not refrected)
- Influence of tsunami : Traces at the seaside of the site, No ingress to buildings

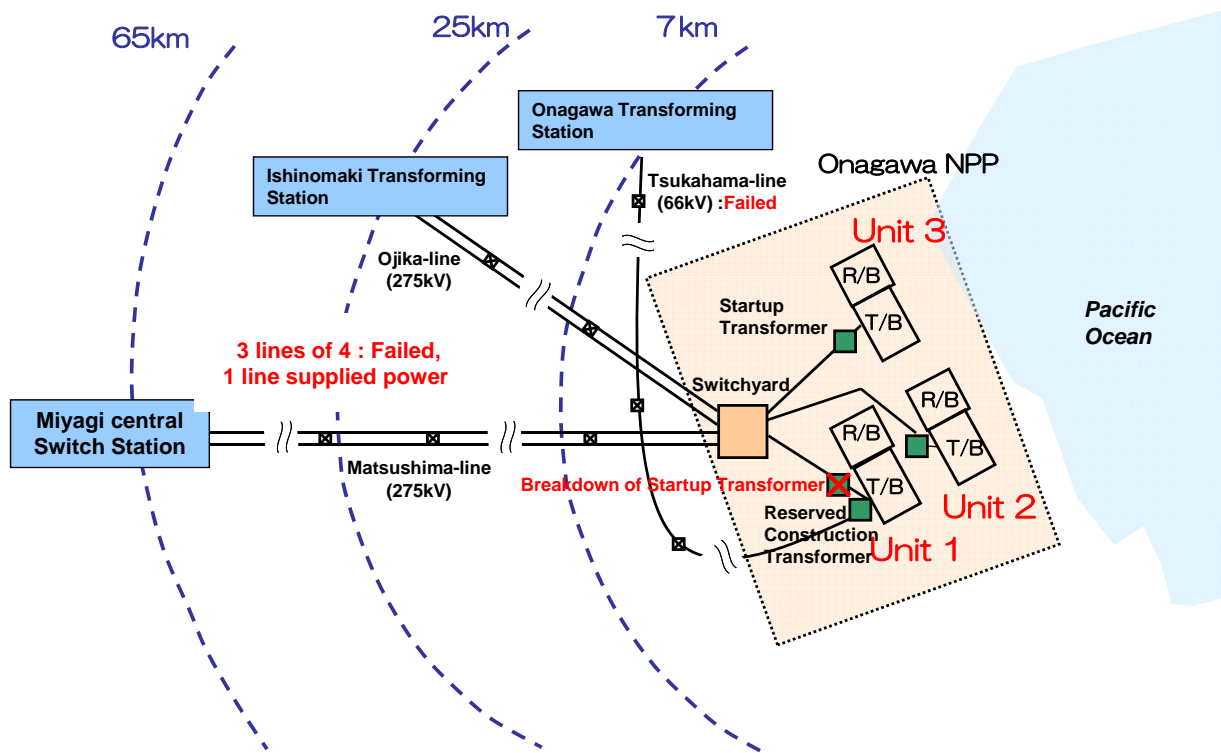
## External Electric Power Network

- Seismic damage to the external power supply system
  - JMA intensity observation
    - Around the Ishinomaki transformer substation: Intensity 6 strong

- Around the Miyagi central switching station: Intensity 6 weak
    - 3 of 4 lines of 275kV were failed by EQ.
    - 1 of 1 line of 66kV failed by EQ.

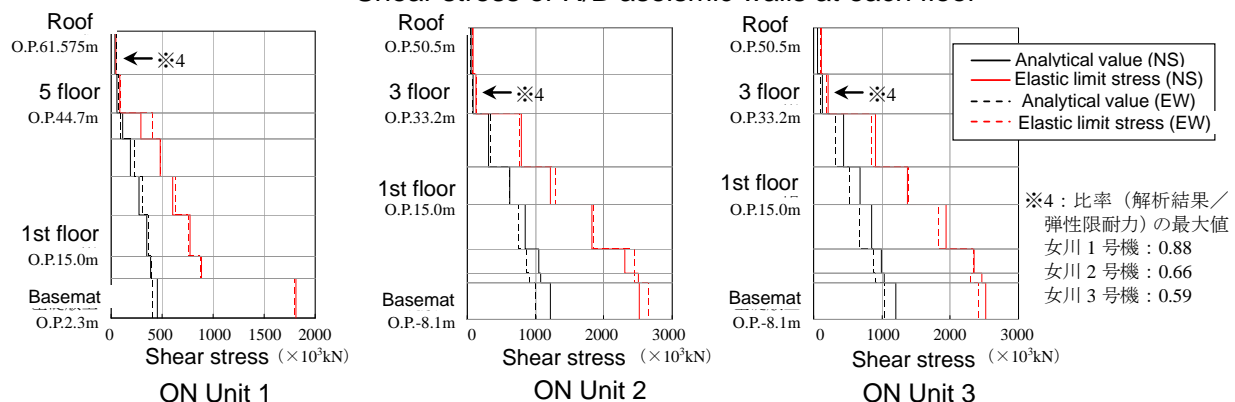
Shear stress of R/B aseismic walls at each floor

- Acceleration motions recorded on the building foundation mat were used as the input seismic motions for Unit 1~3.
- **Assessment results**
  - Shear strain calculated for each floor are lower than the JEAG4681-2008 standard level ( $2.0 \times 10^{-3}$ ). Shear stress and elastic limit stress are also lower than the standard levels.

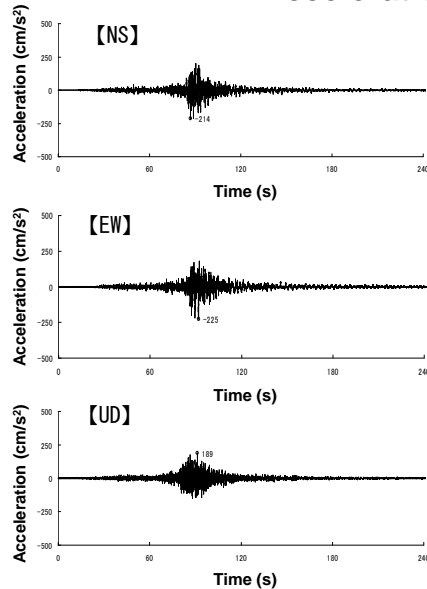
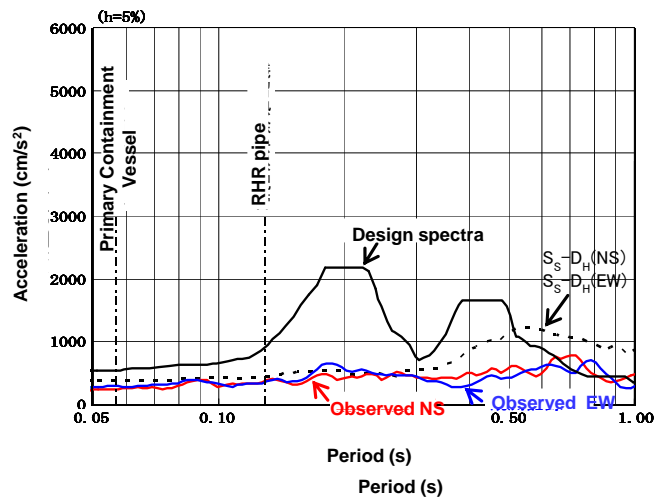
### Acceleration time history on base mat (B2F)

- Max. acceleration of the observed motion is smaller than that of the Ss
- ORS overshoot Ss spectra (DRS) in the range between 0.65 to 0.9 second
- JAPC : ORS is smaller than DRS in the dominant period range of safety important equipment and piping

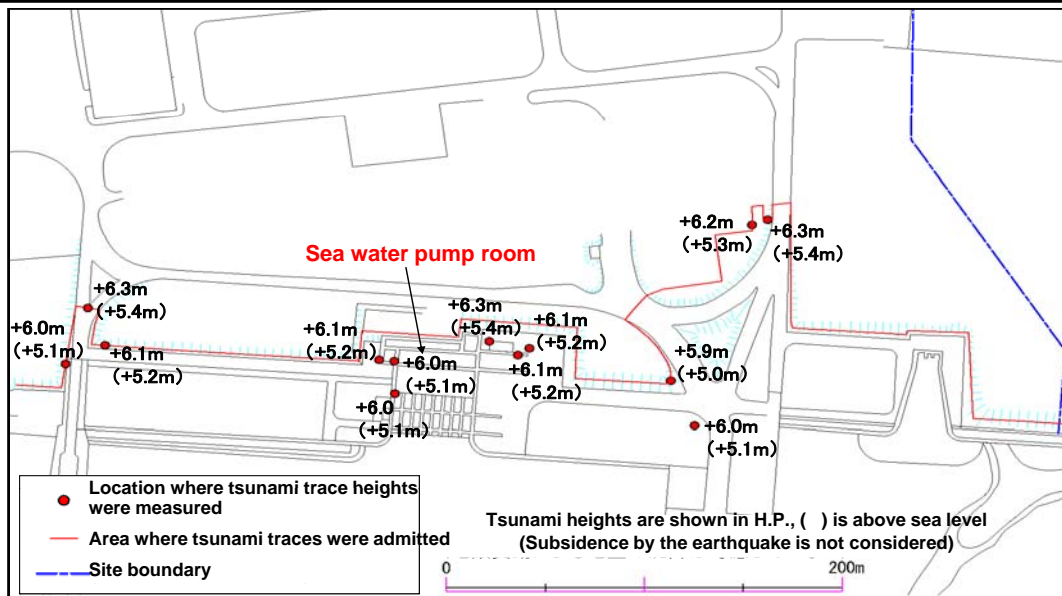
- Tsunami observation system : Tidegauge (at sea wall) + Recording system (at building)
- Outline of recorded tsunami
  - ・Record of tidegauge : Not preserved due to inundation of building
  - ・Tsunami Height : H.P. +5.9m ~ H.P. +6.3m (Tentative)
  - ・Run-up height : About H.P. \* **+6.3m** (Tentative)

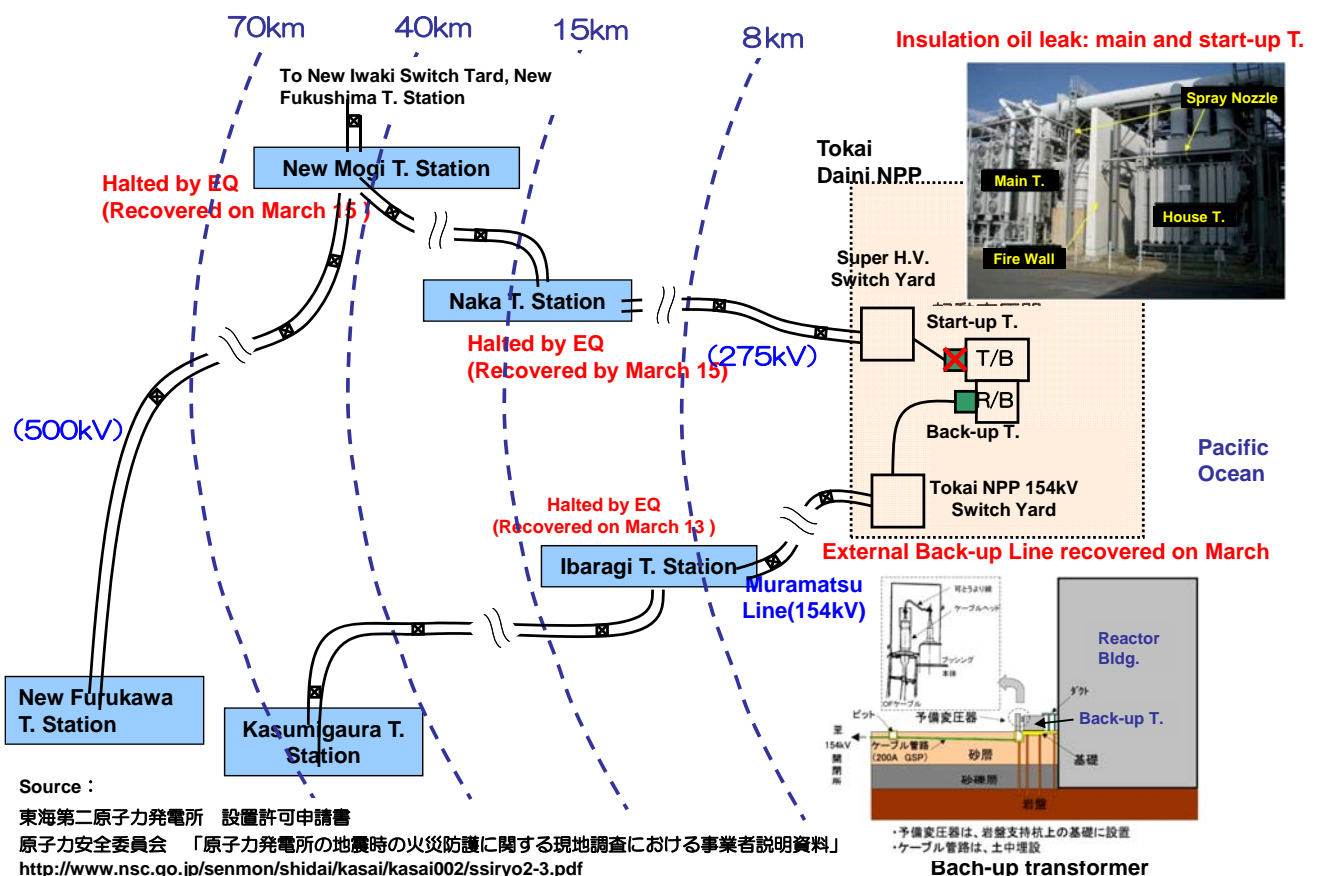
## ■Outline of Power Transmission Line outside of the Site (2)

#### •Insulation oil leak : Main and start-up transformers

#### •All external powers failed but recovered as shown below.
